# A glimpse at what is to come in the era of AI

Jacob Engsig  
COO Microsoft Denmark & Iceland

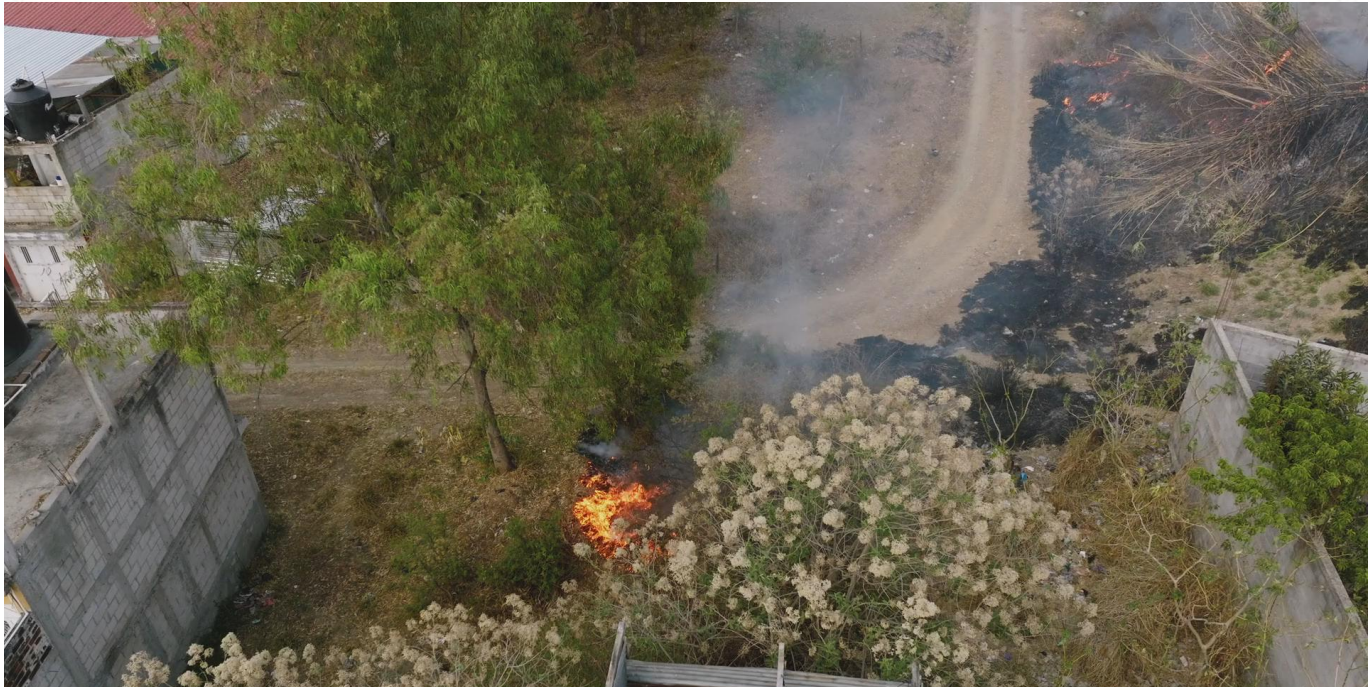
I'm observing a series of images that display a concerning situation. A fire is visible, gradually consuming the vegetation in a confined area. The smoke is becoming denser and spreading outwards. The surrounding environment includes some structures and trees, which could potentially be at risk if the fire continues to spread.

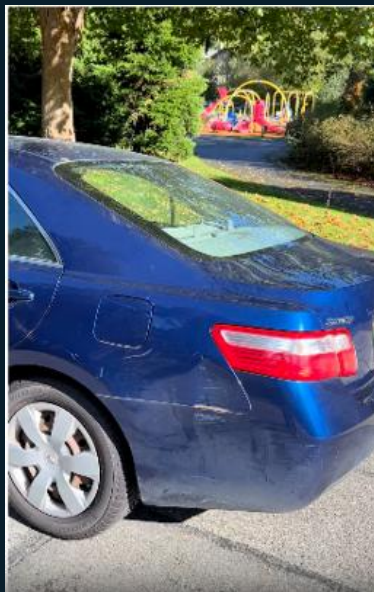
You are an expert in evaluating car damage from car accidents for auto insurance reporting. Create an incident report for the accident shown in the video with 2 sections. Section 1 will include the car details (license plate, car make, car model, approximant model year, color). Section 2 will only include exactly 6 sentence description of the car damage.
